**MERRIMACK RIVER BASIN  
GROVELAND, MASSACHUSETTS**

**JOHNSON CREEK DAM  
AT SALEM STREET  
MA 00188**

**PHASE I INSPECTION REPORT  
NATIONAL DAM INSPECTION PROGRAM**

**OCTOBER 1979**

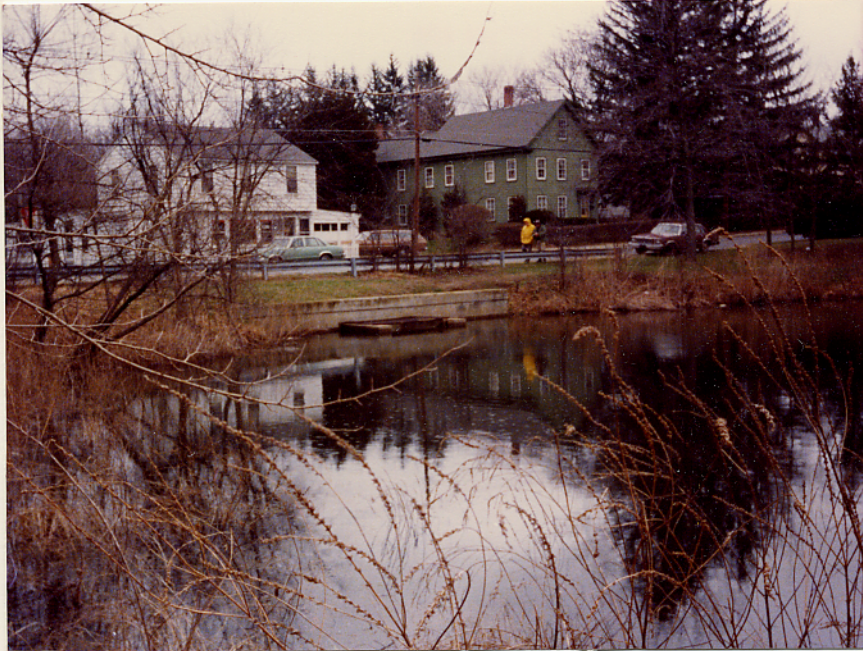
**NO. 1 UPSTREAM FACE AND OUTLET**

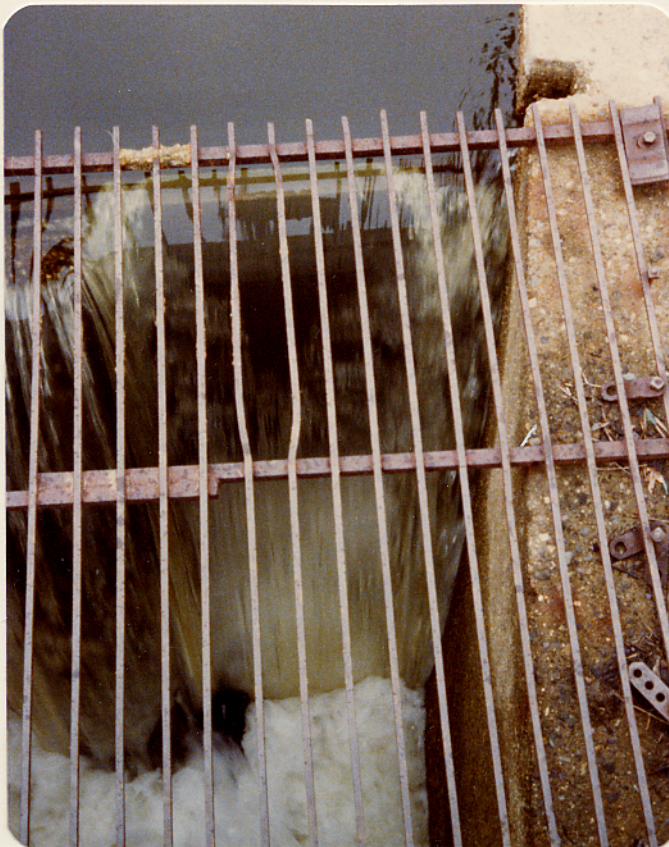
The stoplogs are wedged in place and appear to be difficult to remove. The concrete comprising the outlet structure is in good condition. The approach channel to the outlet is clear of debris, but there is an accumulation of wood and trash downstream of the stoplogs in front of the culvert opening. The low-level outlet is not used and may not be operable. The operating mechanism for the gate valve is missing. The valve is located about 9 feet below the metal grating and underneath water discharging over the stoplogs. This would make the valve difficult to operate during periods of heavy runoff. There is

**NO. 2 WATER DISCHARGING OVER STOPLOGS**

- (5) Make provisions to remove the stoplogs during periods of heavy rainfall.
  - (6) Clear debris from in front of the opening of the culvert.
  - (7) Implement a systematic program of maintenance inspections. As a minimum, the inspection program should consist of a monthly inspection of the dam and appurtenances, supplemented by additional inspections during and after severe storms. Repairs and maintenance should be undertaken in accordance with all applicable State regulations.

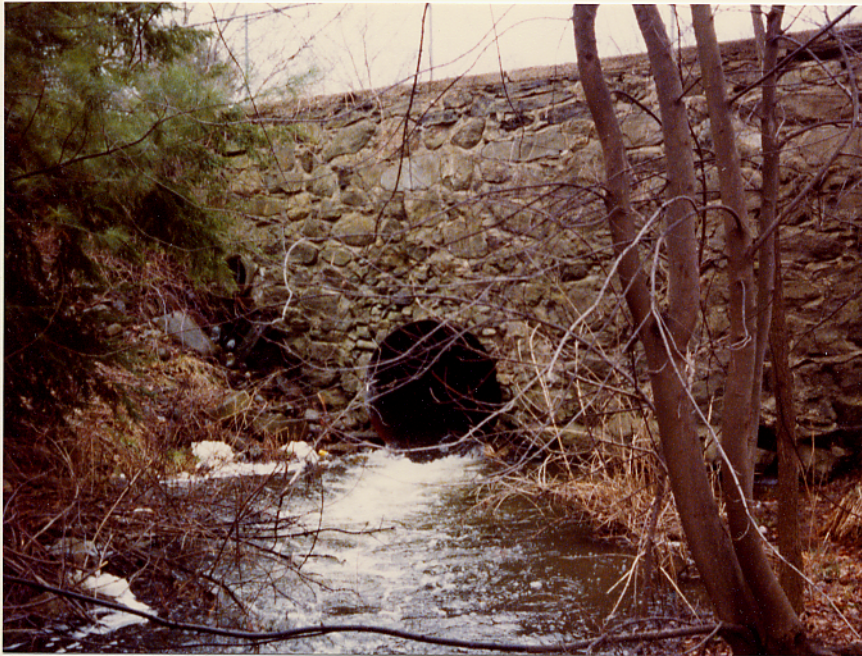
**NO. 3 DISCHARGE CONDUIT AND DOWNSTREAM WALL**

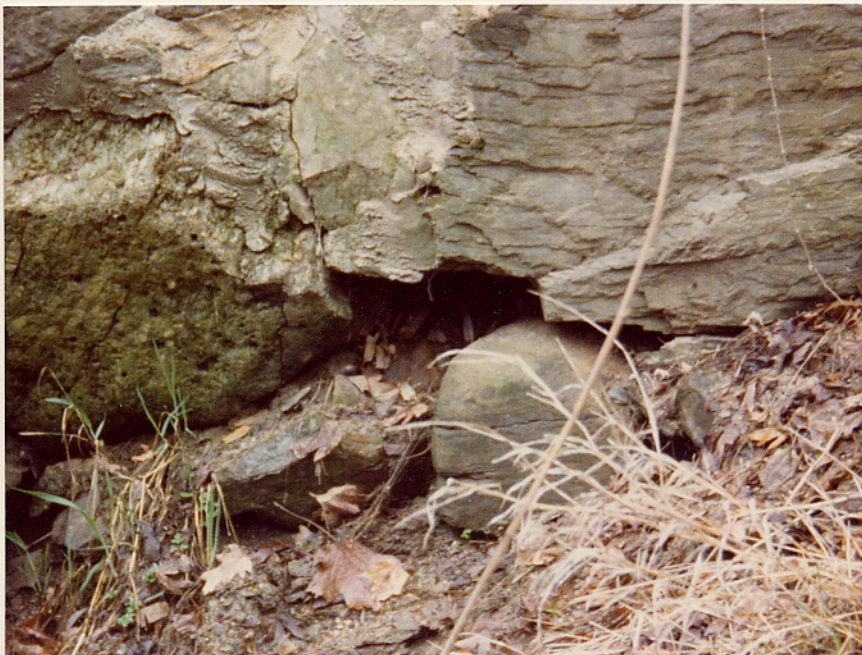
The downstream wall consists of mortared stone masonry that is generally in good condition, although several smaller stones were missing at the foundation level (see photograph No. 4). The mortared joints are generally intact. The wall is topped by a concrete cap which is also in good condition. No evidence of seepage was noted at the downstream wall. Water was discharging from the culvert into the channel at the time of the inspection.

**NO. 4 BLOCKS MISSING IN DOWNSTREAM WALL**

- (2) Repair stones missing from the masonry wall on the downstream face of the dam.
  - (3) Repair erosion behind the headwall of the culvert.
  - (4) Place stone riprap along the upstream face of the dam.

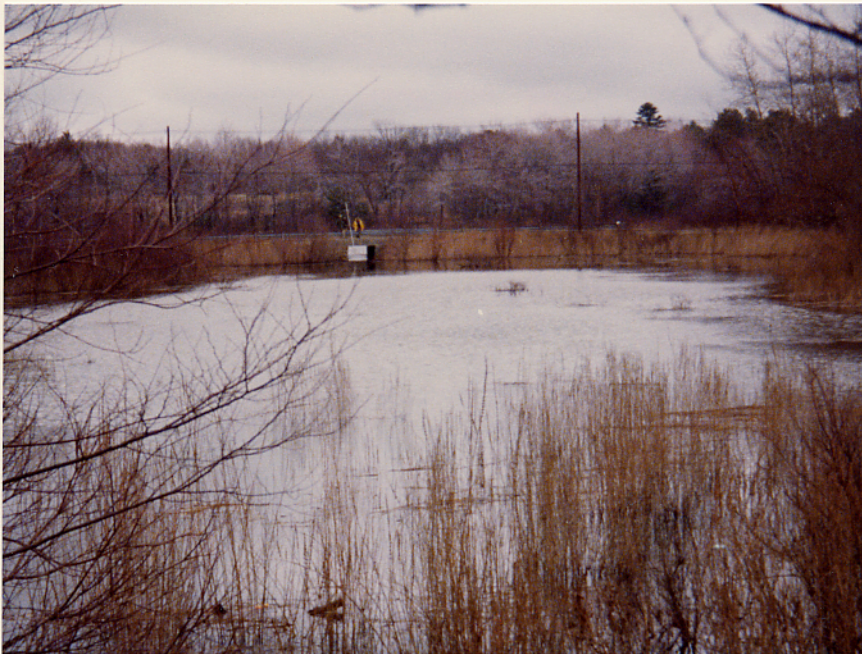
**NO. 5 CONDUIT AT UPTACK ROAD**

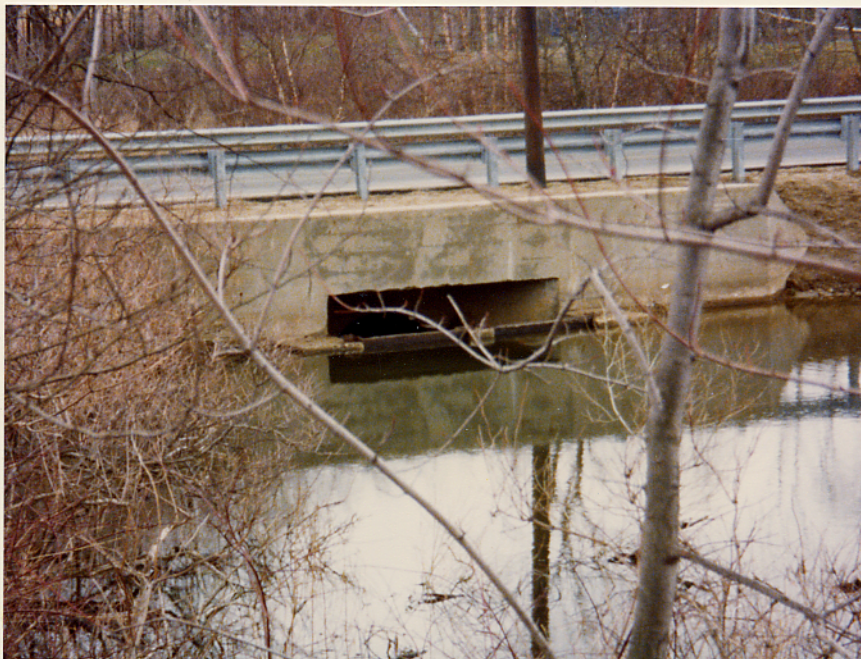
**NO. 6 OUTLET AT WASHINGTON STREET**
